# Manhole Inspection Summary

## Manhole # S43II\_012MH

Insp Date: **4/24/08 12:18 PM**

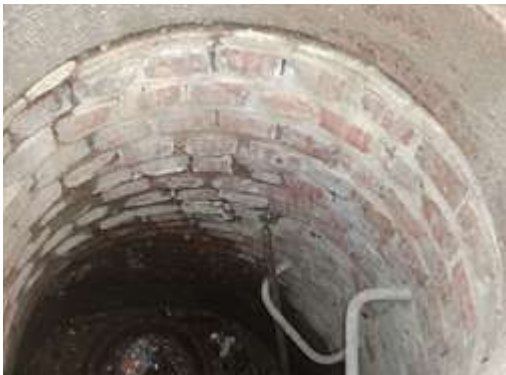
Defect 2

**Frame** Offset: **0** (in.) Condition: ☐ Sound ☐ Cracked ☒ **Leaks**

Frame Leaks

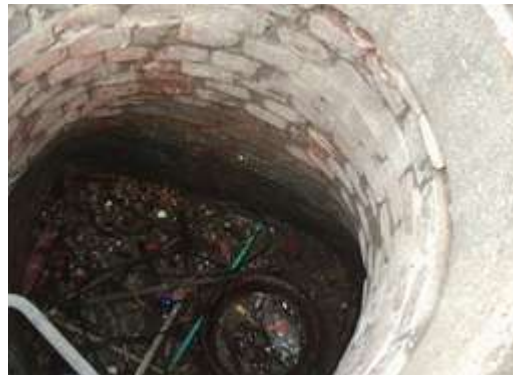
Defect 1

Infiltration: ☐ None ☐ Joint ☐ Cracks ☐ Mortar ☐ Roots ☒ **Wall**

Infiltration

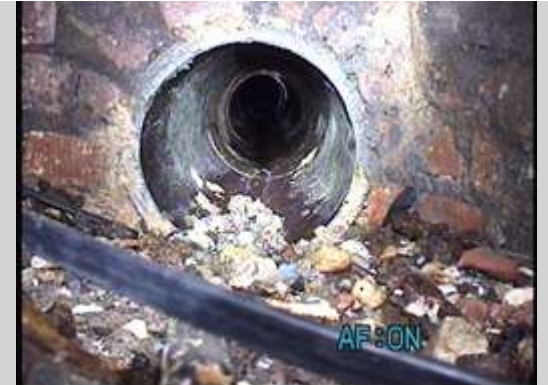
12 O'Clock Outflow

8 in. Circular Gravity Sewer  
Pipe Out @ 12 O'Clock

Infiltration: **None** Pipe Seal Cond: **Sound**
